# Burst Testing of Filament-Wound Graphite-Epoxy Composite Cylindrical Tubes

1 November 2002

This report describes an experimental and analytical program to elucidate the failure process of filament-wound graphite-epoxy tubes, especially the effects of wrinkled fibers and of proof testing on tube burst strength.

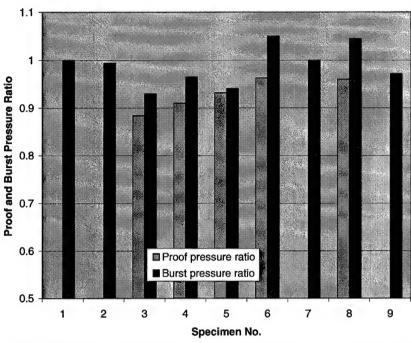
Figure 4.1. Bar charts showing the ratios of proof and burst test pressures for Test Series I. (Average burst pressure of baseline tubes is 2860 psi.)

A total of nine 15-in. specimens were cut from the 11-ft-long tube and tested for this group. Three tubes were tested for establishing the baseline burst pressure. The average burst pressure was 2860 psi. Six tubes were planned for a single proof test before bursting. The ratio of proof pressure to the average burst pressure varied from 0.88 to 0.97. The results of the Test Series I are shown in Table 4.3. Figure 4.1 depicts a bar chart showing the ratios of proof and burst pressures to the average burst pressure for Series I. Specimen No. 9 was intended to be proof tested at 97% of the average burst strength, but failed 5 s into the proof pressure hold. This result implies that a time-delayed failure can occur. Time-delayed failure of graphite-epoxy composite structures is not well understood and requires further study.

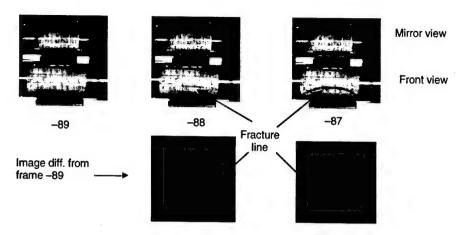
There are typically two fracture modes for Series I. Figures 4.2 and 4.3 depict the two types of failures as well as the subtracted frames from their respective reference frame at 74-µs time intervals. One was a longitudinal mode with a crack running primarily in the axial direction as seen in Figure 4.2. In this figure, frame -89 was the last frame before bursting. In frames -88 and -87, the fracture line is visible in the lower part of the tube. The two photographs in the second row are the subtracted images of frames -88 and -87 from unfractured reference frame -89. There was, however, a small curvature at the center portion of the tube that became large when approaching the end fitting. The large angle at the ends may be the effect of fixed boundary conditions.

Figure 4.2. Longitudinal failure mode and subtracted images showing the failure for test I- 9 (at 13500 fps).

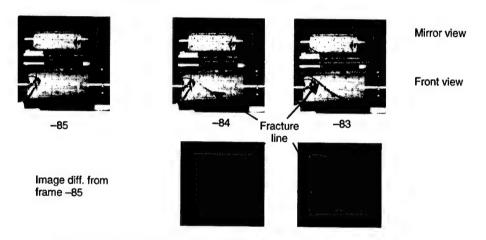
The second type of failure mode was a slanted crack at about 45° from the axial direction, as depicted in Figure 4.3. Frame –85 was the last frame before bursting and serves as the reference frame. Similar to Figure 4.2, the two dark photographs in the second row of Figure 4.3 correspond to the subtracted images in reference to frame –85. In this mode, the fracture ran in the 45° direction and extended through the rest of the tube.

Figure 4.3 Slanted failure mode and subtracted images showing the failure sequence for test I-8 (at 13500 fps).

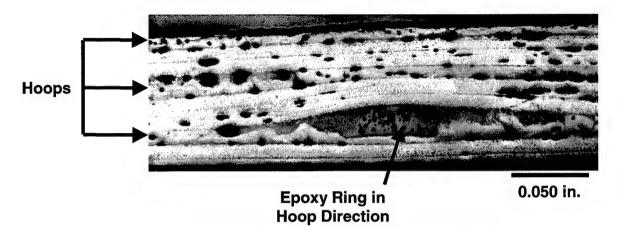
Figure 4.4. Cross-sectional view at wrinkle of a helically wrinkled tube.

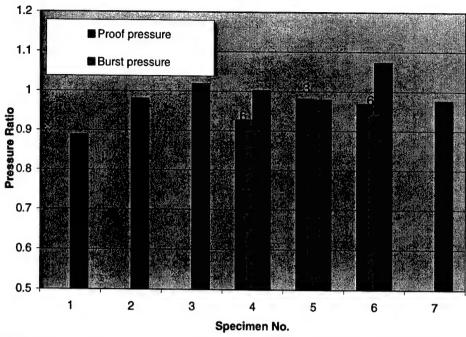
Figure 4.5. Bar charts showing proof and burst test ratios for Test Series II. (Average burst pressure of baseline tubes is 3005 psi.)

above each light-gray bar indicates the number of proof tests conducted for this particular specimen. The burst pressure of the un-wrinkled specimen, II-1, was 2667 psi. This burst pressure was significantly lower than the burst pressure values of the wrinkled segments from the same tube. The fact that this segment was cut from the end of the 11-ft tube might be the cause of the abnormal burst pressure.

The six wrinkled segments were tested in two conditions: three were pressurized directly to burst, and three were proof tested before burst. For each proof cycle, the peak pressure was maintained for 2 min before venting. As seen in Table 4.4, there were no differences in burst pressures between proof-tested and un-proof tested specimens other than typical data scatter for composite materials. A typical pressure-time history plot is depicted in Figure 4.6.

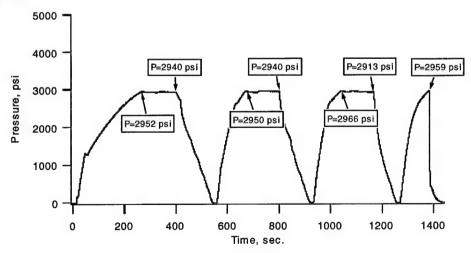
Figure 4.7. Pressure-time history for Specimen II-5.

For specimen II-5, there may be a proof test effect on the strength of the specimen. The specimen was pressurized three times to 98.1% of the average burst pressure. The specimen, however, failed while the proof pressure was reached on the fourth cycle without being able to sustain the 2-min-long hold. This showed that the specimen strength might have been degraded by the previous three proof cycles. Figure 4.7 depicts the pressure-time history of this test.

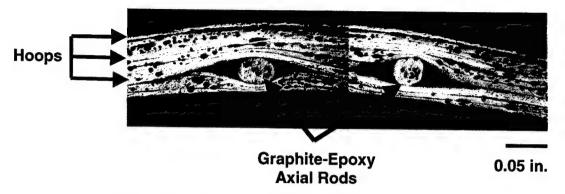
Figure 4.8. Cross section view at wrinkle of a hoop wrinkled tube.

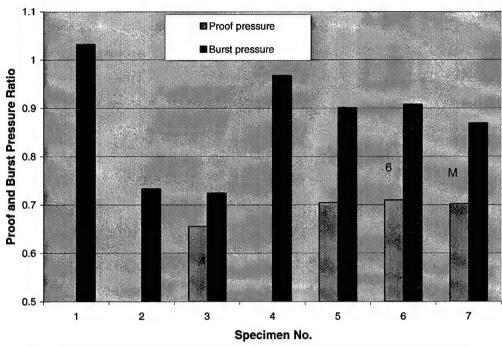
Figure 4.9. Bar charts showing the ratios of proof and burst test pressures for Test Series III. (Average burst pressure of un-wrinkled tube is 2992 psi.)

The test results shown in Table 4.5 indicate that a hoop wrinkle significantly reduces the burst pressure. The fabricated hoop wrinkle was much more effective in degrading the strength than the helical wrinkle. The burst pressure was reduced by 10–27% of the pressure for un-wrinkled specimens. Figure 4.9 depicts the bar charts showing the ratios of proof and burst test for this test series. The number "6" corresponding to specimen No. 6 indicates that this tube was proof tested six times before burst. The letter "M" indicates that the specimen III-7 went through 4 multiple proof test cycles as listed in Table 4.5. It should be noted that one tube was cut for microstructural examination so that only seven specimens were available for testing.

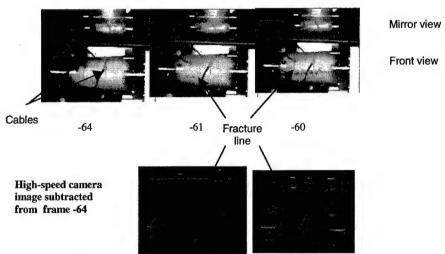
The failure mode of Test Series III (hoop wrinkles) was different from those observed in Test Series I and #2. Unlike the two failure modes in Figures 4.2 and 4.3, the failure path in these hoop-wrinkled tubes was strongly dominated by the existence of the longitudinal rods. Figure 4.10 depicts the typical failure mode for wrinkled tubes in this series. Frame -64, an un-fractured frame, served as the

Figure 4.10. Failure mode and subtracted images showing the failure sequence of Test III-7 (at 13500 fps).

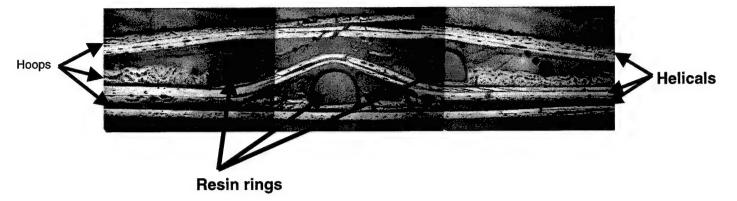
Figure 4.12. Typical cross section of a helical wrinkle for Tube IV. (From post-test piece of Test IV-4.)

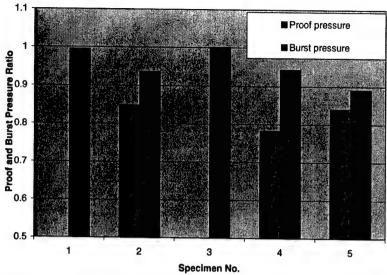
Figure 4.13. Bar charts showing proof and burst test ratios for Test Series IV. (Average burst pressure of un-wrinkled tube is 7653 psi.)

The test results shown in Table 4.6 indicate that the helical wrinkles fabricated in this series reduce the burst pressure. The amount of reduction ranges from 6 to 11% based on an average burst pressure of 7653 psi. The embedded resin rings induced localized bending stress to the helical fibers in addition to the pressure-induced membrane stress. Figure 4.13 depicts the bar charts showing the ratios of proof and burst tests for this test series. From Figure 4.13, three data points do not indicate that the proof-pressure ratios (0.78 to 0.85) had any effect on the burst pressure.

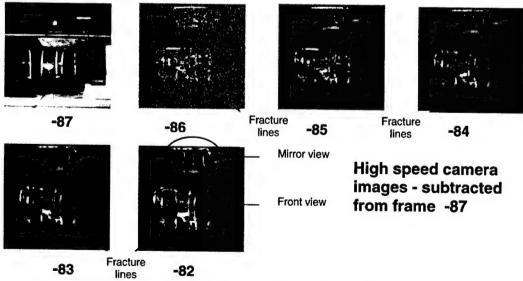
The failure mode of the specimens in this test series is different from those in Series I, II, and III. In the previous three series, the failures were dominated by the hoop fibers with little influence from the helical fibers. This was true because there were half as many fibers in the hoop direction as in the helical direction, while the hoop stress was twice the stress in the axial direction. For this series, the amount of fibers is more or less balanced in both directions. The stress in the helical fibers became more significant at burst pressure, especially in the wrinkle region. Figures 4.14 through 4.16 depict the subtracted images for specimens IV-1, IV-2, and IV-5. Specimen IV-1 had no wrinkle, while specimens IV-2 and IV-5 were wrinkled. From these three figures, it can be seen that the failure for specimen IV-1 was hoop-fiber dominated, the failure of specimen IV-2 was mixed, and the failure of specimen IV-5 was helical-fiber dominated.

Figure 4. 14. Passure mode and subtracted images showing the failure sequence of Test IV-1 (no wrinkle) (at 13500 fps).

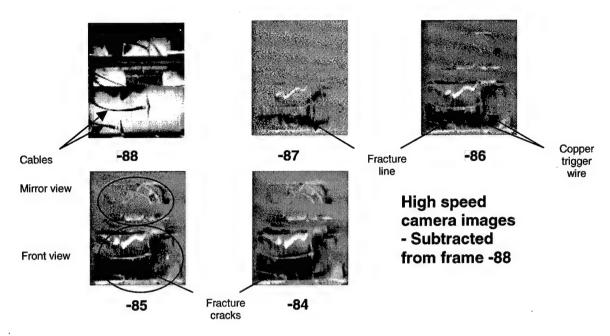
Figure 4. 15. Failure mode and subtracted images showing the failure sequence of Test IV-2 (at 13500 fps).

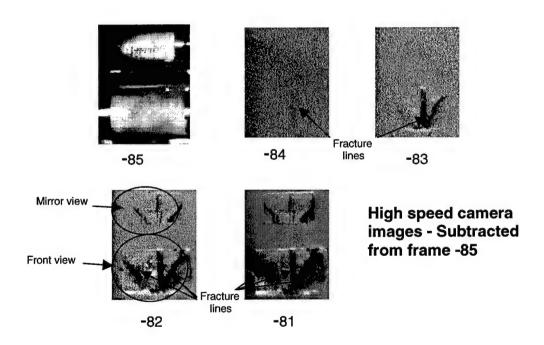
Figure 4.16. Failure mode and subtracted images showing the failure sequence of Test IV-5 (at 13500 frames/s).

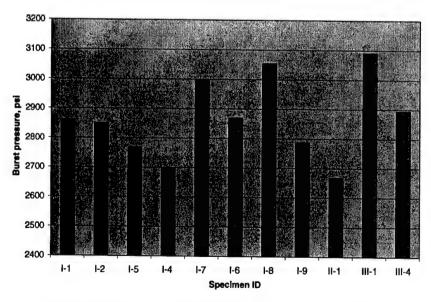
Figure 4.17. Burst pressures for all flaw-free specimens from Test Series I, II, and III.

The average burst pressure of 11 tested flaw-free tubes from Series I, II, and III was 2860 psi with a standard deviation of 137 psi or 4.8%. Figure 4.17 depicts the burst pressures of these 11 specimens. The 6 tubes with the minor helical wrinkle had an average burst pressure of 3022 psi with a standard deviation of 109 psi or 3.6%. The tubes with hoop wrinkles had an average burst pressure of 2475 psi with a standard deviation of 271 psi or 11.0%. Test conditions included straight burst testing, single proof tests followed by burst, and multiple proof tests followed by burst. Some of the tubes were proof tested to levels as high as 98% of the average burst pressures, and some were cycled to these proof pressures as many as six times before bursting.

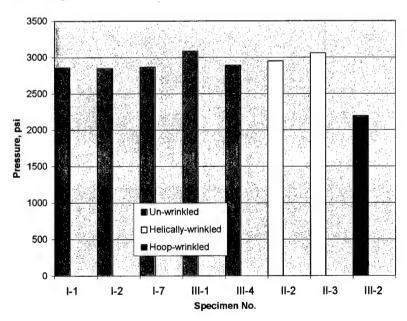
Figure 4.18. Effects of wrinkles on burst pressure with no proof pressure.

To show the hoop wrinkle effect, Figure 4.18 was constructed to include all the tube burst data in the same three test series without any proof cycle. The data came from three groups: 5 tubes free from defects, two tubes with helical defects, and a tube with a hoop wrinkle. Figure 4.18 demonstrates that the burst pressures of our helically wrinkled specimens are comparable to those free from defects. The average burst pressure of these seven specimens is 2939 psi. However, the burst strength of the hoop-wrinkled tube falls 25% below the 2939 psi average.

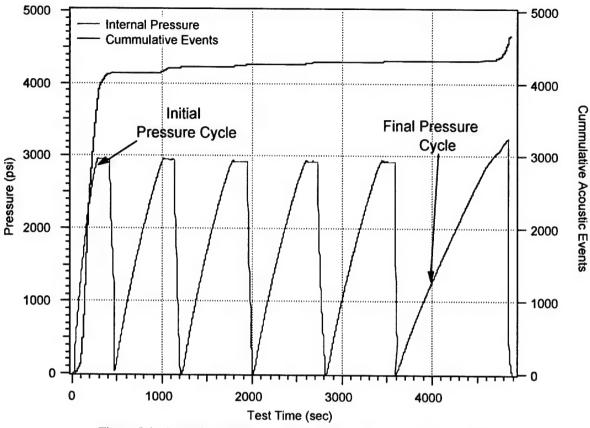
Figure 5.4. Acoustic emission recorded while pressure cycling Tube # II-6.

An important result from this testing was that all of the tubes exhibited the Kaiser effect. The Kaiser effect is the observation that under cyclical loading, undamaged materials will not generate significant additional acoustic emission events until the structure is subjected to a load that exceeds any previous load. This behavior can be used to detect damage that might occur between cycles. An example of the AE signature displaying the Kaiser effect is shown in Figure 5.4. Note that essentially all of the AE occurred during the initial tube pressurization and the final cycle after the pressure had exceeded the previous maximum pressure of ~2975 psi. The small number of events that did occur during the intermediate cycles were caused by noise in the pressurization system.

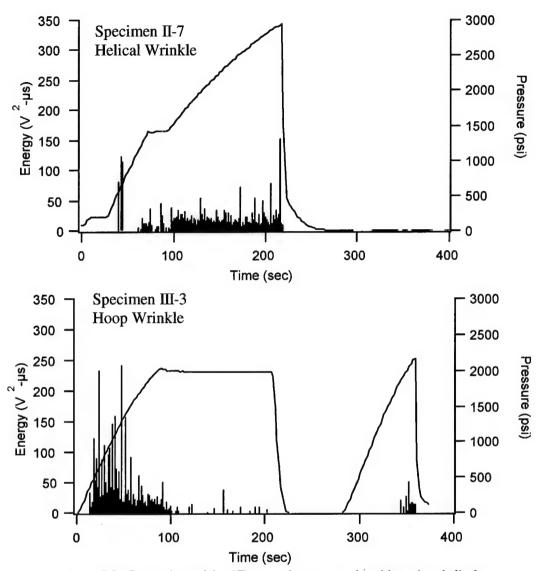
Figure 5.5. Comparison of the AE energy between a tube with a minor helical wrinkle and one with a hoop wrinkle.

The AE monitoring did provide an excellent method for discriminating between tubes with a nominal burst pressure and those that burst low. During pressurization, the tubes that burst low (i.e., tubes with hoop wrinkles) had more higher-energy events at low pressures than their nominal counterparts. An example of this is shown in Figure 5.5 for tubes typical of both types. The red traces correspond to pressure (right scale), and the blue traces correspond to acoustic energy (left scale).

hoop-wrinkled tubes with burst strengths below 2500 psi. The hoop-wrinkled tubes had increased acoustic activity in the wrinkle region at pressures well below the helical-wrinkled tubes. However, during the pressurization cycles, none of the tubes in the study generated any evidence of delamination growth even though delamination growth was predicted to occur before burst. At pressurization levels approaching the burst strength of the nominal tubes, a subtle decrease in the acoustic-event generation rate was noted. This signature has the potential to provide an indication of imminent tube failure. However, additional work is required to determine how best to exploit this acoustic data.

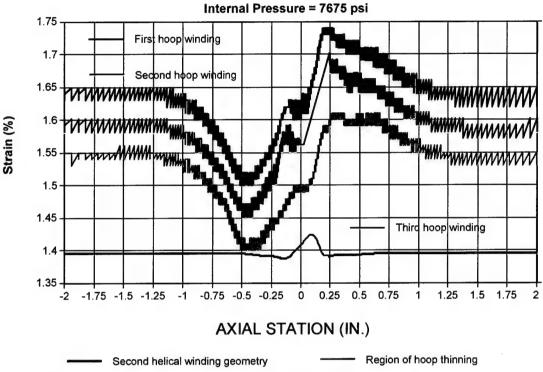
Figure 6.5. Predicted hoop strains in 12-ply tube with a helical wrinkle (Series IV).

The predicted strains in the hoop fibers are shown in Figure 6.5 for an internal pressure of 7675 psi. This value was a preliminary estimate for the average burst pressure for tubes from Series IV (tubes without wrinkles). After all testing was completed, the actual average burst presure was 7653 psi. However, the difference between the two values is very small (0.3%), so for all practical purposes, the analysis results below are representative of a typical composite tube. The figure shows strain as a function of axial station along the cylinder. The zero position is midway between the two rods.

Also shown in Figure 6.5 is the helical wrinkle geometry (exaggerated scale for clarity). The purple section of the wrinkle is the region of hoop thinning. Through-thickness variations in strain for each winding are shown on the plot. As expected, the largest hoop strain occurs at the ID of the innermost hoop ply. The maximum predicted strain away from the wrinkle area is 1.65%. This value is fairly close to the earlier prediction from composite laminate analysis (Table 6.5) (maximum strain in hoop fibers = 1.70%).

At the location of the wrinkle, the FEM model predicts a maximum hoop strain of 1.74% at the innermost hoop ply underneath the right-hand side of the wrinkle. Hence, the strain concentration

factor caused by the wrinkle is:  $S_{\epsilon} = 1.74\%/1.65\% = 1.054$ . It follows that tubes with helical wrinkles should fail at a burst pressure given by:  $p = 7675 \text{ psi/S}_{\epsilon} = 7675 \text{ psi/}(1.054) = 7282 \text{ psi}$ . This predicted burst pressure value is only slightly higher (3%) than the average burst pressure of 7078 psi for the three tubes from Series IV that contained helical wrinkles. Thus, the FEM analysis predicts the burst pressure of tubes with helical wrinkles fairly well.

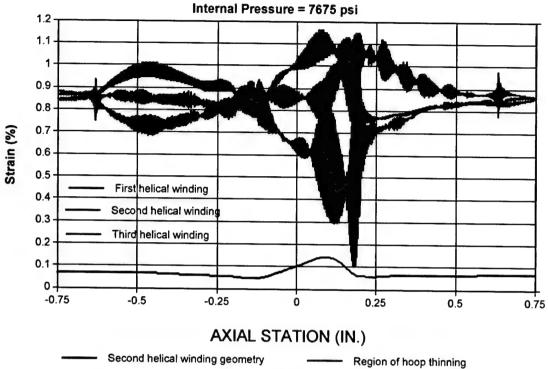
Figure 6.6. Predicted helical strains in 12-ply tube with a helical wrinkle.

Figure 6.6 shows the predicted strains in the helical windings. The average helical strain away from the wrinkle is about 0.87%. This agrees with the laminate analysis in Table 6.5 fairly well if the strain at the midsection of the laminate (0.82%) is taken. It is clear that the laminate analysis overpredicts the variation in helical strains across the tube wall. This reflects the fact that the laminate analysis represents the tube as a flat plate, and bending effects are much larger for cylindrical specimens. In Figure 6.6, the second helical ply contains the wrinkle. As expected, there are large variations in strain near the wrinkle region, especially at the right-hand side of the wrinkle where the curvature is sharpest and hoop thinning is present. The strains are not, however, near the ultimate strain capability of the fibers.

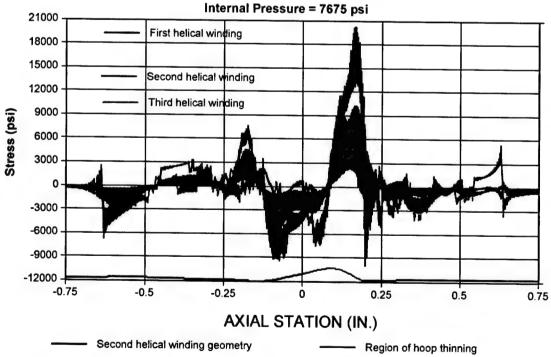
Figure 6.7. Predicted interlaminar shear stresses in 12-ply tube with a helical wrinkle.

The interlaminar shear stresses in the helical plies are shown in Figure 6.7. The stresses are fairly benign, except in the region of high curvature near the wrinkle. The large shear stresses could, in principle, induce a delamination. One of the puzzling aspects about the present investigation is why delamination cracks did not grow at the wrinkle under high loads. No significant AE emissions were recorded that could be associated with large-scale delamination growth. Other aspects of the tube failures, such as the high burst pressures, are also consistent with the absence of large-scale delamination.

nation cracks. Apparently some other factor must have reduced the tendency for delamination, in spite of the high shear peaks in Figure 6.7. It is possible that the cross-ply stress, which is under compression, may play a role in reducing delamination.

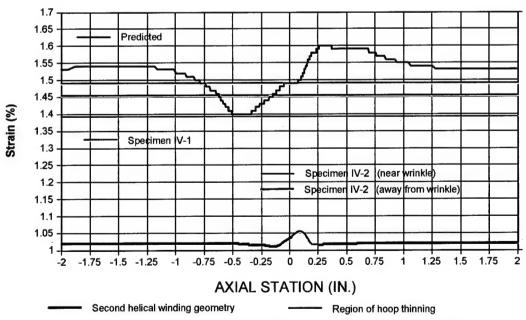
Figure 6.8. Outer surface hoop strains in 12-ply tube with a helical wrinkle, scaled to 7675 psi internal pressure.

Strain gages were employed on two tubes from Series-IV: specimen IV-1, which had no wrinkles and which burst at 7630 psi; and specimen IV-2, which contained a helical wrinkle and burst at 7177 psi. A single rosette gage was employed on the outer hoop ply of specimen IV-1. This gage measured hoop, axial, and 45° off-axis strains. Two such gages were employed on specimen IV-2, one near the wrinkle and one far away from it. The predicted hoop strains on the surface of a specimen with a helical wrinkle are shown in Figure 6.8, along with the strain gage data (normalized to a pressure of 7675 psi). The FEM analysis gave a hoop strain of 1.53% on the outer surface of the tube, away from the wrinkle. The measured strain for an unwrinkled specimen is 1.49%. Hence, the far-field strain predictions are in good agreement with the data, with an error of only 3%. At the wrinkle location, the hoop strain was calculated to be in the range 1.4–1.6%. This compares with an experimental value of 1.39% (adjusted to a pressure of 7675 psi). Since the strain gage has a length of 0.0625 in., it averages strains over a short dimension. Therefore, the experimental data cannot capture the highest peaks in the strain field. Considering these factors, the agreement between predictions and experiments at the wrinkle looks good.

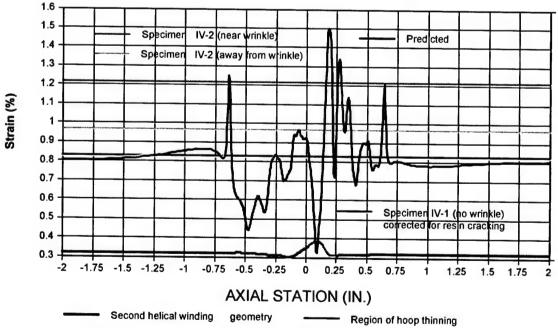
Figure 6.9. Outer surface axial strains in 12-ply tube with a helical wrinkle, scaled to 7675 psi internal pressure.

The predicted axial strain at the wrinkle varies greatly, especially near the crest of the wrinkle, as shown in Figure 6.9. The scaled measured strain (specimen IV-2) for the gauge near the wrinkle is within this range, though on the high side. No firm conclusions can be drawn on the accuracy of the analysis for axial strains at the wrinkle, given the variability in the experimental data.

at a wrinkle must be caused primarily by bending and stiffness distortions associated with the wrinkle geometry. The secondary effect of "hoop thinning" does not contribute significantly to a reduction in burst pressure. It is important to note, however, that this conclusion could be different if the hoop thinning existed over a greater length scale (axial direction) in the tube. Evidently, the composite is able to re-distribute stresses caused by hoop thinning, provided these are localized in extent.

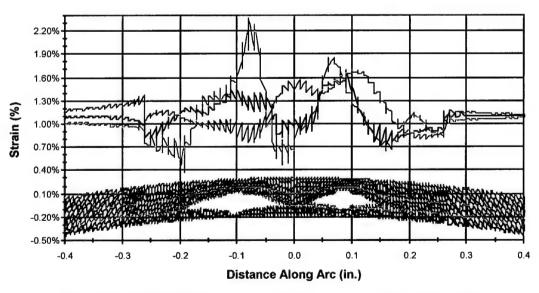
Figure 6.10. Predicted hoop fiber strains for hoop wrinkled tube ran at 2716 psi.

Figure 6.4 shows the geometry for the hoop wrinkle model, and Figure 6.10 presents the strains in the hoop fibers for an internal pressure of 2716 psi (burst pressure of Tube III-6, which was proof tested six times to 2125 psi prior to final burst). The largest hoop strain occurs on the innermost hoop winding. This follows the same trend as the analysis for helical wrinkles. The maximum predicted far-field strain (away from wrinkle) was 1.11%. The maximum predicted hoop strain at the wrinkle location was 2.35%, which occurred in the left-hand resin pocket (where the curvature of the inner hoop winding is sharpest). Thus, a bending failure is expected in this region due to the curvature of the hoop fibers around the resin pocket. The predicted burst pressure of a tube with a hoop wrinkle,

based on data for tubes without wrinkles, is (1.11/2.35) x 2716, or 1283 psi. This value is much lower than the burst pressures of four specimens containing hoop wrinkles: 2195 psi, 2168 psi, 2695 psi, and 2716 psi. Hence, there is a wide discrepancy between the analysis and experiments for tubes with hoop wrinkles.

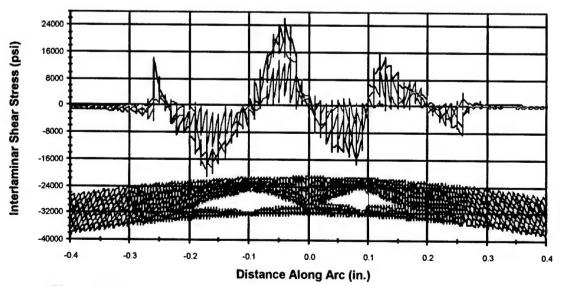
Figure 6.11. Predicted interlaminar snear stresses for noop wrinkled tube ran at 2716 psi.

The predicted interlaminar shear stress results are shown in Figure 6.11. The stresses vary greatly over the entire wrinkle region, reversing in sign several times. The regions of peak shear stresses are very narrow, and it seems plausible that small local delaminations could have formed within the tube wall. Just as for the case of helical wrinkles, there was no experimental evidence that any significant delamination cracks grew during testing. Hence, the analysis reaches the same puzzling conclusion as for helical wrinkles. Based upon the shear stress peaks, it seems as if delamination and progressive damage should have occurred in the composites, prior to final burst of the tubes. This is clear from Figure 6.11 because the peak shear stress is 24 ksi, which exceeds typical interlaminar strengths in these composites. Hence, the progressive damage mechanism was inhibited, for reasons that are unknown.

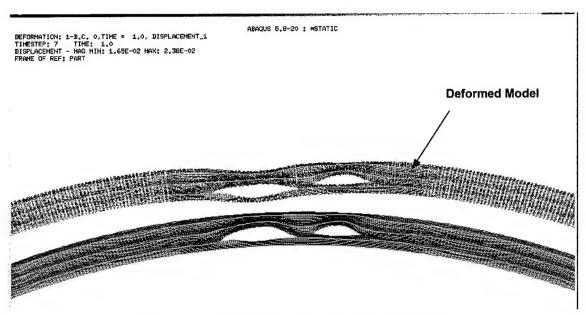
Figure 6.12. Displacement results with 15% magnification.

The deformation plot in Figure 6.12 indicates that internal pressurization of the tube causes the innermost wavy hoop ply to straighten out. The middle hoop winding, which is also initially wavy, deforms in a similar manner. It follows that the outer surface of the tube bulges radially when the tube is pressurized. Experimental evidence, particularly Moiré fringe measurements, has confirmed

the existence out-of-plane displacements in the tube surface during pressure tests. This result is significant because it indicates that internal wrinkles in composite cylinders might be detected during proof tests if some type of whole-field strain analysis is done on the specimen surface. The technique is likely to be most effective for wrinkles that are not buried too deep in the cylinder wall. The present analysis model shows significant bulging because the tube wall is thin, so bending deformations are more likely.

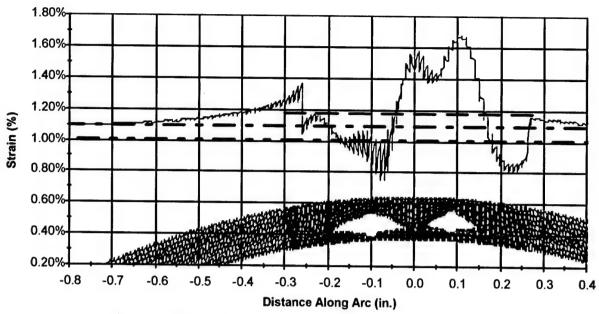
Figure 6.13. Outer surface hoop strains in 9-ply tube with hoop wrinkles.

The measured strain at the wrinkle for specimen III-6 (at burst) was 1.172%. The corresponding predicted strains vary from 1.16 to 1.53% over the region of the wrinkle. Thus, the measured strain is within the predicted range, near the lower end. As was noted earlier, it would be expected that the strain gauge averages out localized strains due to the length of the gage. Hence, the comparison between experimental and analysis results is not unreasonable.

It is believed that the main reason why the analysis does not do a better job of predicting the burst strength of tubes with hoop wrinkles is due to localized damage in the composite. High strains within the hoop fibers are associated with localized bending, where the wavy plies have a high curvature. These high strains might be reduced considerably if small delaminations stopped the transfer of bending strains into the plies. However, modeling this effect would call for a detailed progressive damage package, which was beyond the scope of the current study. Therefore, future attempts at refining the predictions for burst pressures will need to include nonlinear effects and progressive crack formation within composites. It is also possible that the placement of the axial rods caused some discrepancies between theory and experiment. The analysis used an average position for the rods, but there was some variation on a specimen-to-specimen basis.

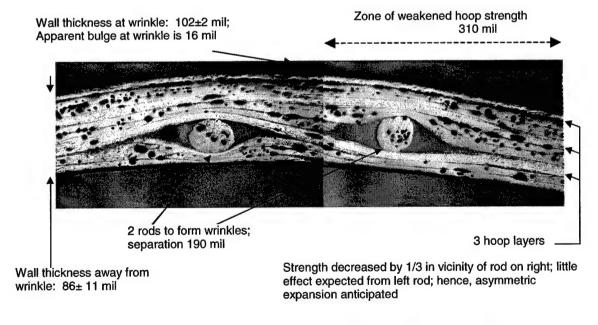
Figure 7.3. Cross section of 4-in. tube with hoop wrinkle. There are 3 hoop layers of which a single layer, the innermost, is under the right hand rod.

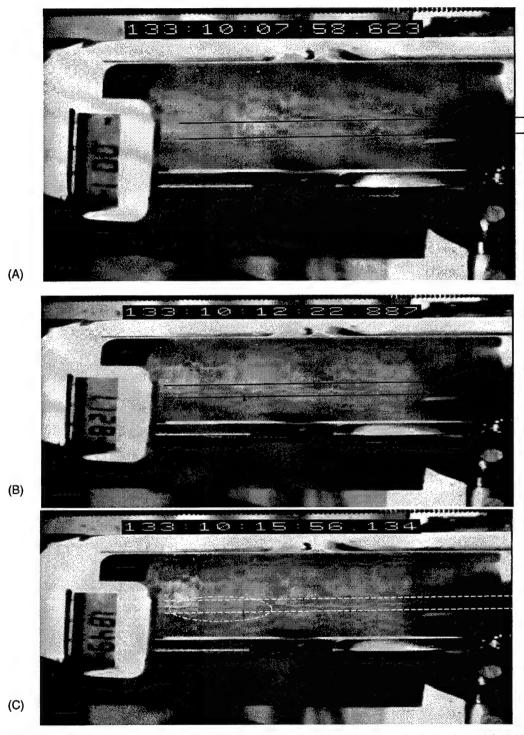
When the tube is unpressurized [Figure 7.4(A)], a plateau is observed defined by the two rods. As pressure was increased, the height contours showed that more deformation was occurring in the vicinity of a single rod in an asymmetric sense in agreement with prediction of deformation. In the vicinity of the non-protruding rod, the plateau is observed to disappear and is virtually indistinguish-

Figure 7.4. Moiré image of size 2.8 in. (v) and 8 in. (h). The dashed lines indicate the rod forming the hoop defect. There are periodic discontinuities formed by steps in the outer epoxy coat from a helical tape wrap. Pressures are (A) 0 psi, (B) 1500 psi, and (C) 2500 psi. The elliptical zone in (C) is where this tube eventually burst at 2695 psi. From 1500 psi upward, a ridgeline is observed coinciding with a rod causing the hoop defect. It is on this ridgeline that the sample eventually ruptured.

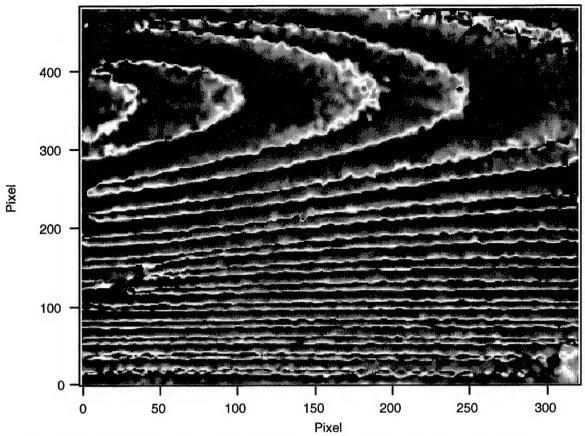
The result of using the three step or four image method is shown in Figure 7.9 for a hollow composite tube in which a deformation is produced by placing a wrench of a few pounds into the center of the tube. This phase image was measured by the camera on the lower left side as one faces the tube from the position of the illuminator beam. It represents the projection of deformation in the direction of the viewing camera. The tube is supported by a cradle beneath the tube by two "vee" blocks. In the upper part of the image corresponding to the lower part of the tube, a modest amount of deformation is seen. Each fringe corresponds to  $\lambda/2$  change along the camera's line of sight that is out of the plane of the image.

Figure 7.9. The phase of an empty graphite epoxy tube deformed by placing a wrench into the center of the tube. The image is switched around, upside-down and left to right. The motion of the tube is complex. Fringes in the lower right corner are not well defined due to poor signal levels. The phase is shown as varying from 0 to  $2\pi$  as the intensity is modulated from 0 to 256 gray scale. The field of view is about 5.0 x 6.0 cm on the tube.
